Your Inspection Report

94-555 Aloha Way
Honolulu, HI 96789

RE: Report No. 1002, v.2
94-555 Aloha Way
Honolulu, HI
96789

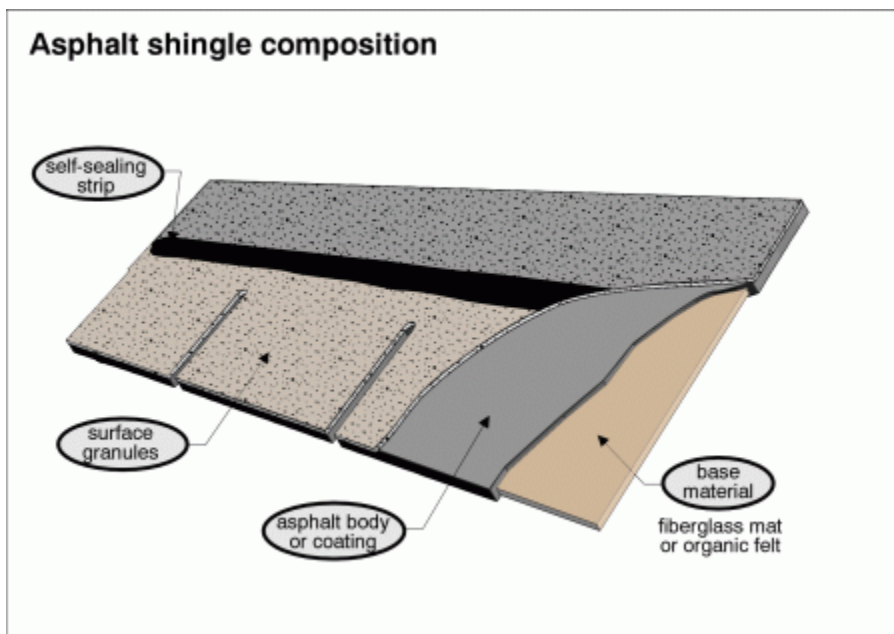
Condition: • [Granule loss](#)

Implication(s): Chance of water damage to contents, finishes and/or structure

Location: Throughout ridge

Task: Replace by a licensed roofing specialist

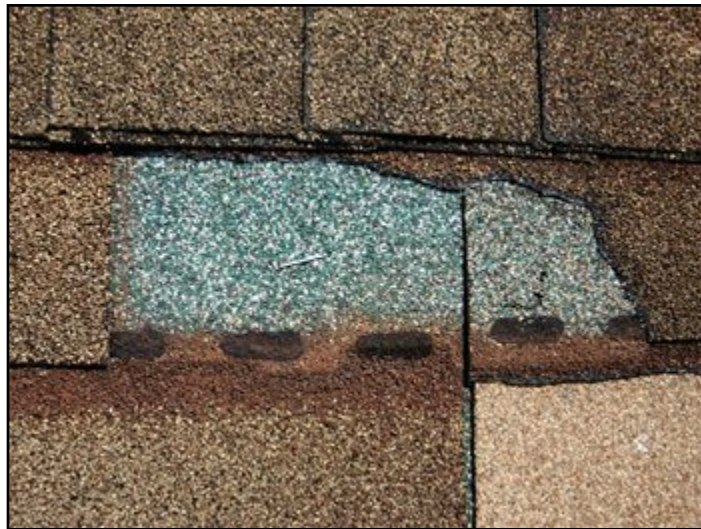
2.

Condition: • [Missing, loose or torn](#)

Shingles are missing or torn. Some areas have been patched in the past.

Implication(s): Chance of water damage to contents, finishes and/or structure

Location: Various areas

Task: Replace by a licensed specialist

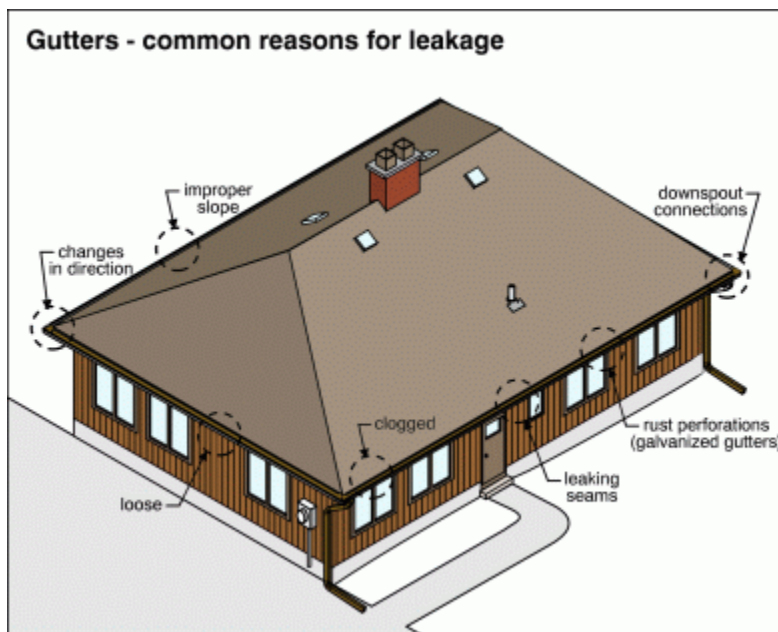
Condition: • [Loose or damaged](#)

Implication(s): Chance of water damage to contents, finishes and/or structure

Location: Left Side Second Floor

Task: Repair by a licensed specialist

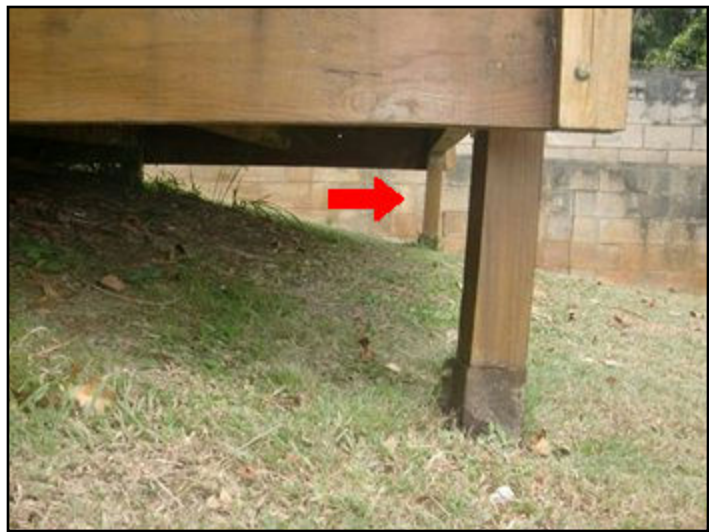
4.

Condition: • [Leaning](#)

The deck posts are racked and not properly supporting the deck. The deck should not be used until evaluated and corrected.

Implication(s): Weakened structure | Chance of movement

Location: Front

Task: Repair by a licensed specialist

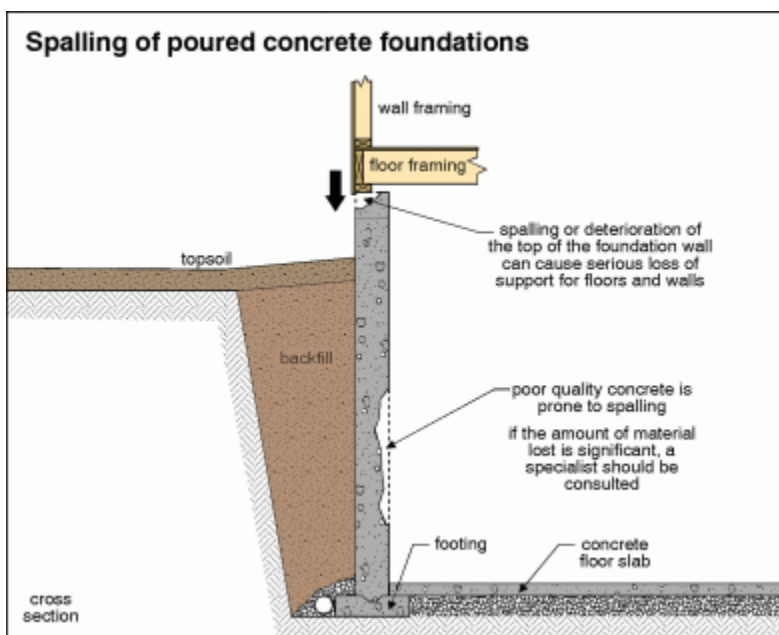
- Condition:** • [Spalling, crumbling or broken material](#)

The condition appears to have come from excessive moisture due to the sprinkler system hitting foundation wall.

Implication(s): Weakened structure | Chance of structural movement

Location: Rear

Task: Further evaluation by a licensed specialist to determine the extent of condition and for any repairs if necessary.

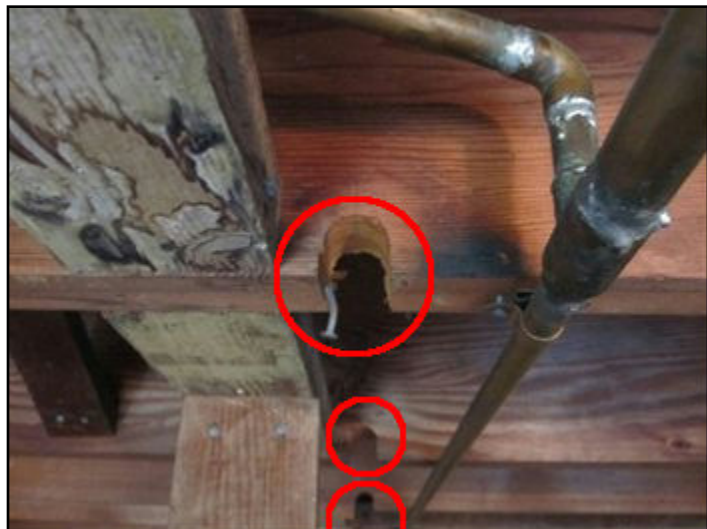
6.

Condition: • [Notches or holes](#)

The joists have been notched out for the older plumbing. The joists should be reinforced at these points.

Implication(s): Weakened structure

Location: Front Crawl Space

Task: Correct the issue.

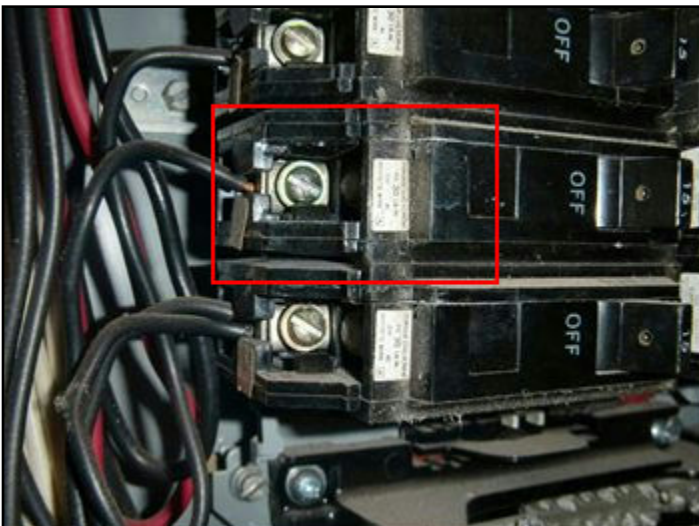
7.

Condition: • [Overheating](#)

The thermal image is showing signs of overheated wiring. The circuit is labeled for the bedroom outlets. The red areas in the thermal picture indicate higher temperatures and an irregular heat pattern.

Implication(s): Fire hazard

Location: Utility Room

Task: Further evaluation by a licensed specialist to determine the extent of condition and for any repairs if necessary

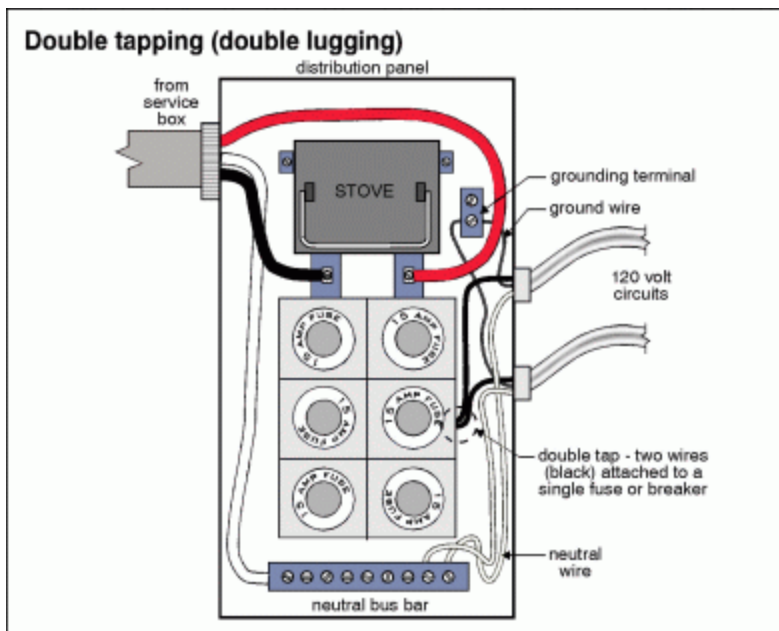
Condition: • [Double taps](#)

Additional breakers should be added to support additional circuits. Wires can become loose at the connections causing arcing and overheating.

Implication(s): Fire hazard

Location: Distribution Panel

Task: Repair by a licensed electrician

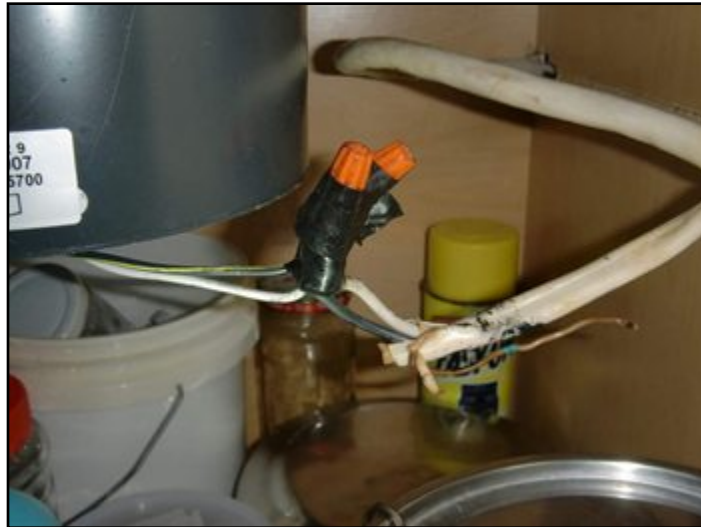
10.

Condition: • [Open splices](#)

Implication(s): Electric shock | Fire hazard

Location: Kitchen

Task: Repair by a licensed specialist

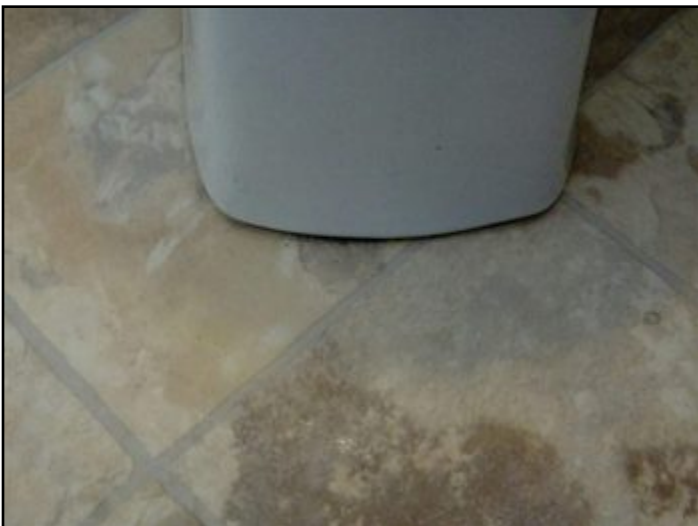
Condition: • [Leak](#)

The thermal image shows water leakage in the blue colored areas. The leak is coming from the base of the toilet bowl.

Implication(s): Chance of water damage to contents, finishes and/or structure

Location: First Floor Hallway Bathroom

11. Toilet

Task: Repair by a licensed specialist

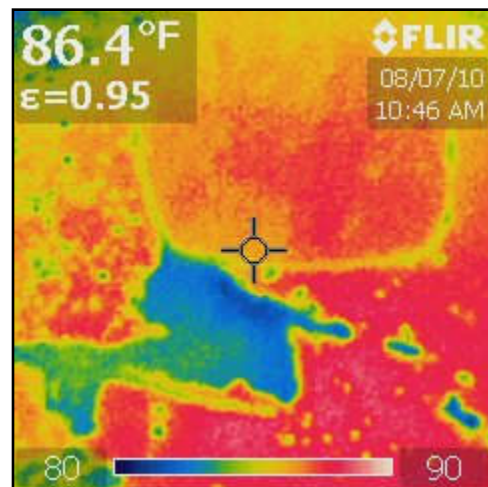
12. Toilet (thermal image)

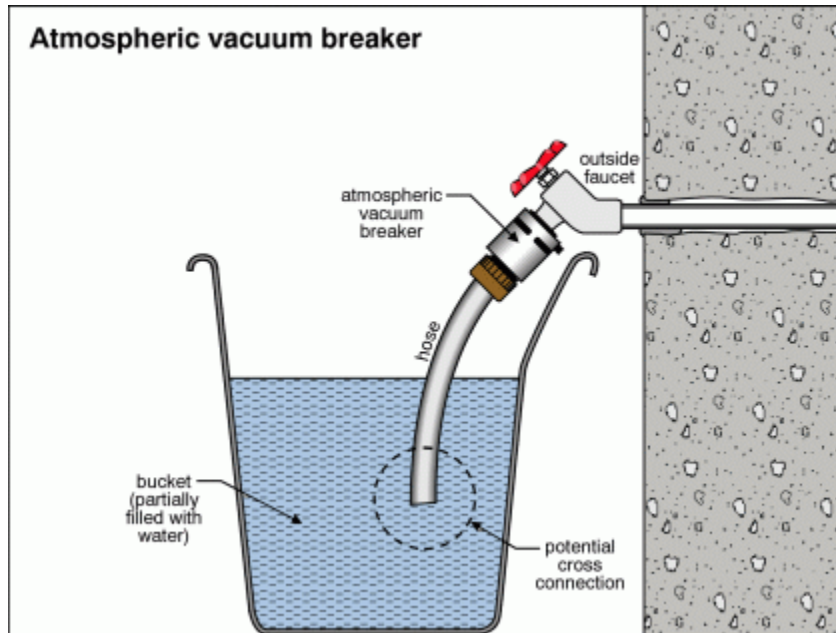
Condition: • [Backflow prevention missing](#)

Implication(s): Contaminated drinking water

Location: Throughout Exterior

Task: Provide

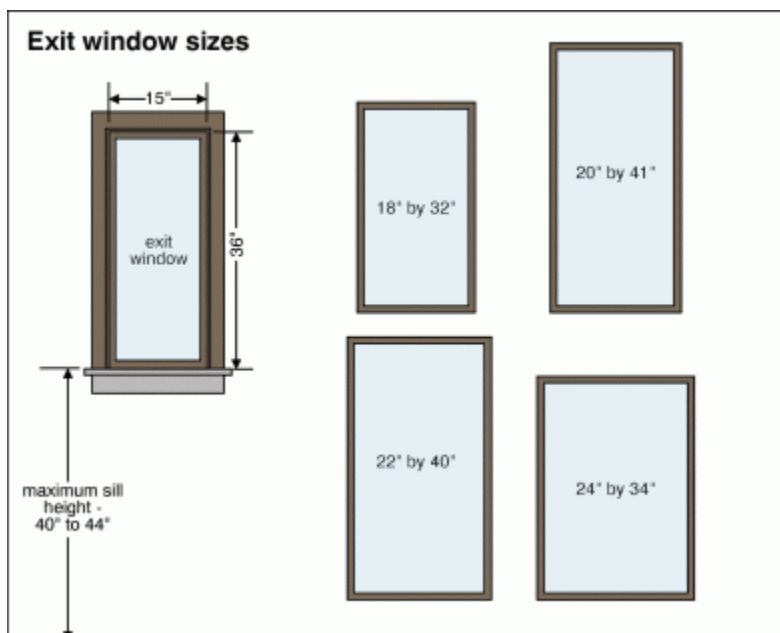
- Condition:** • [Too small](#)
- Implication(s):** Restricted emergency exits
- Location:** Front Bedroom
- Task:** Correct the issue
- Time:** Immediate

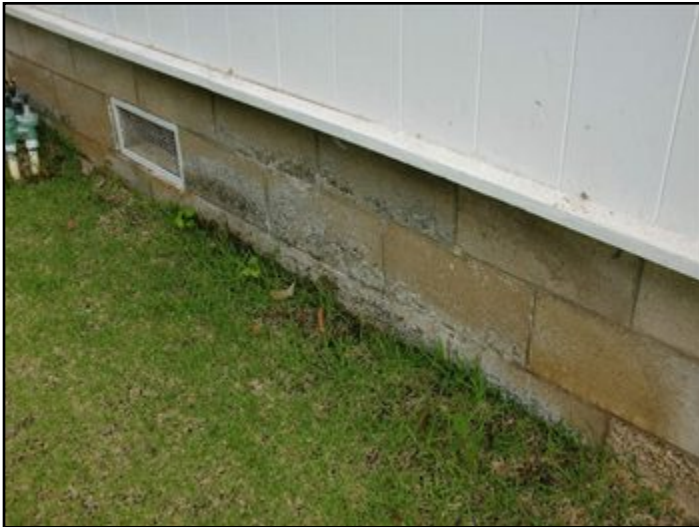
Condition: • [Dampness on floor or walls](#)

The thermal image shows high levels of moisture in blue. The foundation wall has excessive moisture levels which is seeping through into the crawl space.

Implication(s): Cosmetic defects | Chance of water damage to contents, finishes and/or structure | Material deterioration

Location: Rear Crawl Space

13. Rear foundation

Task: Improve the condition

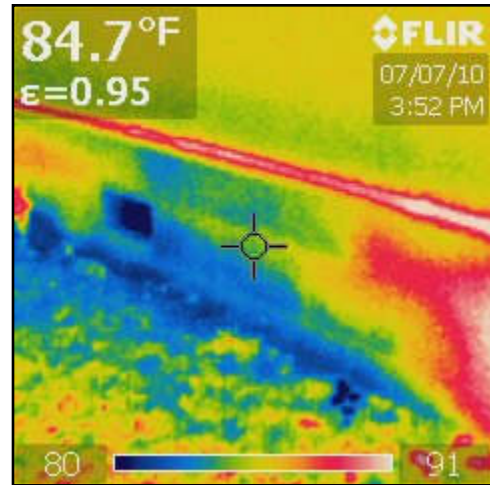
14. Rear foundation (thermal image)
